# Infinitum 1013

FACING BRICKS  
CATEGORY I, U

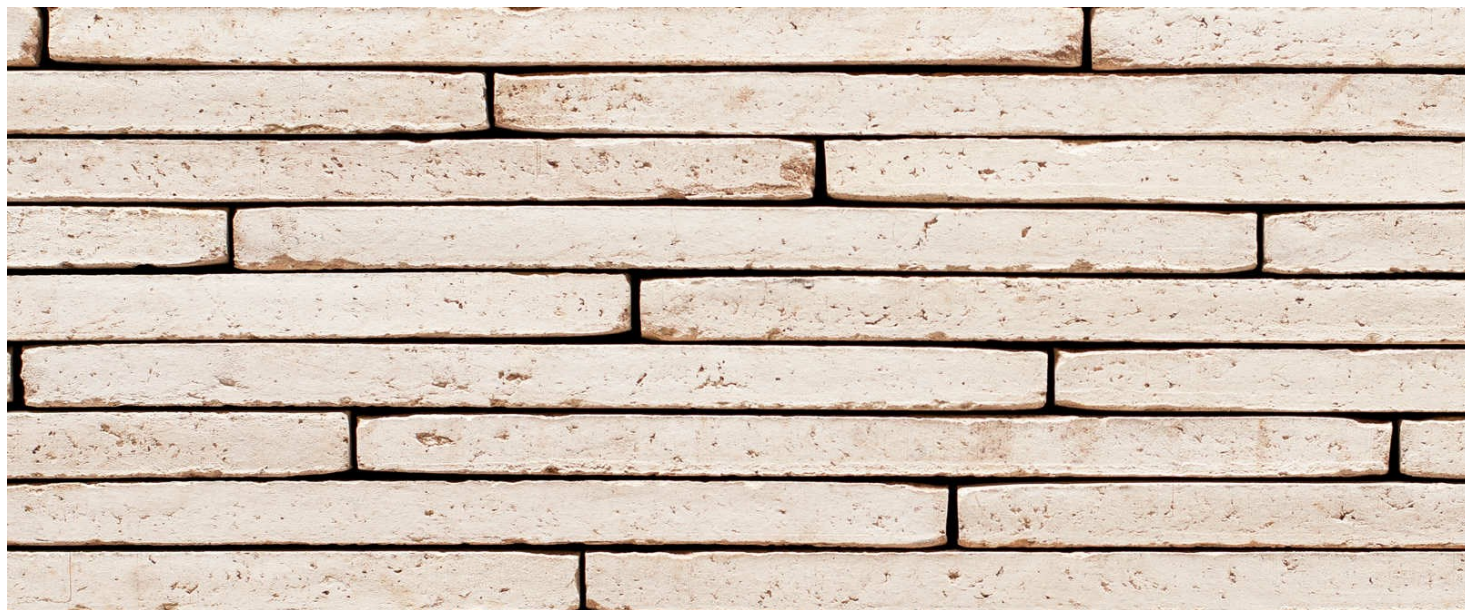
## Productshot

The decorative brickwork (inside and/or outside face) is made with a solid unsanded moulded brick without grain with a very uneven structure. Due to the natural reduction with coal the bricks have a strong fired rough field fire aspect. Some visible sides of the brick also contain traces of coal and of the manual production method. The colour is ecru to cream-white with nuances through and through.
