# **Infinitum 6013**

FACING BRICKS CATEGORY I, U

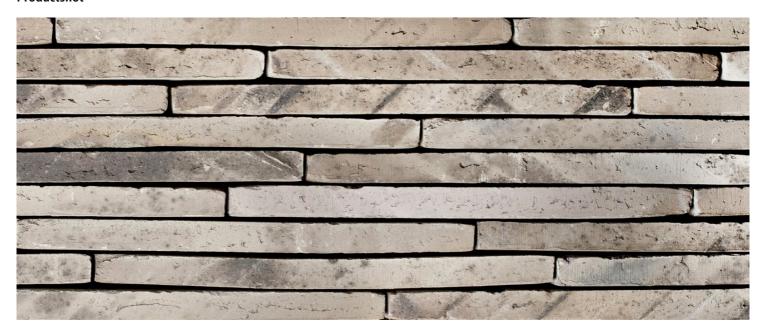
## Productshot

The decorative brickwork (inside and/or outside face) is made with a solid unsanded moulded brick without grain with a very uneven structure. Due to the natural reduction with coal the bricks have a strong fired rough field fire aspect. Some visible sides of the brick also contain traces of coal and of the manual production method. The colour is light green-grey to brown-grey with a black-grey surface structure.
