linea 6012

FACING BRICKS
CATEGORY I, U

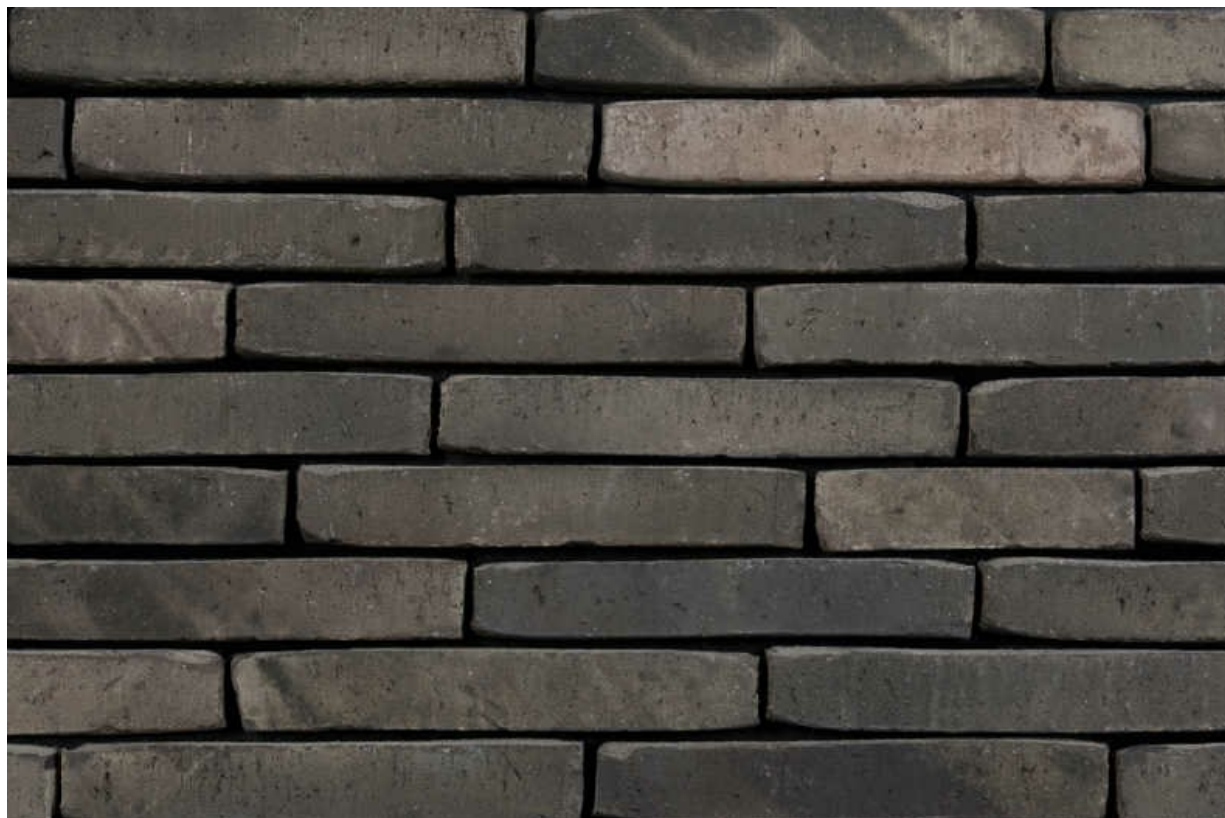
Productshot

The decorative brickwork (inside and/or outside face) is made with a solid unsanded moulded brick without grain with a very uneven structure. Due to the natural reduction with coal the bricks have a strong fired rough field fire aspect. Some visible sides of the brick also contain traces of coal and of the manual production method. The colour of the body is grey-green-brown to black-green with nuances.
